Subject: Department of Natural Resources Washington Geological Survey,  
School Seismic Safety Assessment Project, Contract No. AE 410 -  
Seismic Evaluation for **Boistfort School District**

### **School Buildings Evaluated in the Boistfort School District**

Building Name:	Gymnasium Building
Facility Name:	Boistfort Elementary
District Name:	Boistfort
ICOS Latitude:	46.55
ICOS Longitude:	-123.133
ICOS	
County/District ID:	21234
ICOS Building ID:	16933
ASCE 41 Bldg Type:	RM1
Enrollment:	99
Gross Sq. Ft. :	14,530
Year Built:	1963
Number of Stories:	1
S <sub>XS</sub> BSE-2E:	0.948
S <sub>X1</sub> BSE-2E:	0.610
ASCE 41 Level of Seismicity:	High
Site Class:	D
V <sub>S30</sub> (m/s):	320
Liquefaction Potential:	Moderate to High
Tsunami Risk:	None
Structural Drawings Available:	No
Evaluating Firm:	WRK Engineers

Building Name:	Main Building
Facility Name:	Boistfort Elementary
District Name:	Boistfort
ICOS Latitude:	46.55
ICOS Longitude:	-123.133
ICOS	
County/District ID:	21234
ICOS Building ID:	18408
ASCE 41 Bldg Type:	URM
Enrollment:	99
Gross Sq. Ft. :	18,935
Year Built:	1936
Number of Stories:	1
S <sub>XS</sub> BSE-2E:	0.948
S <sub>X1</sub> BSE-2E:	0.610
ASCE 41 Level of Seismicity:

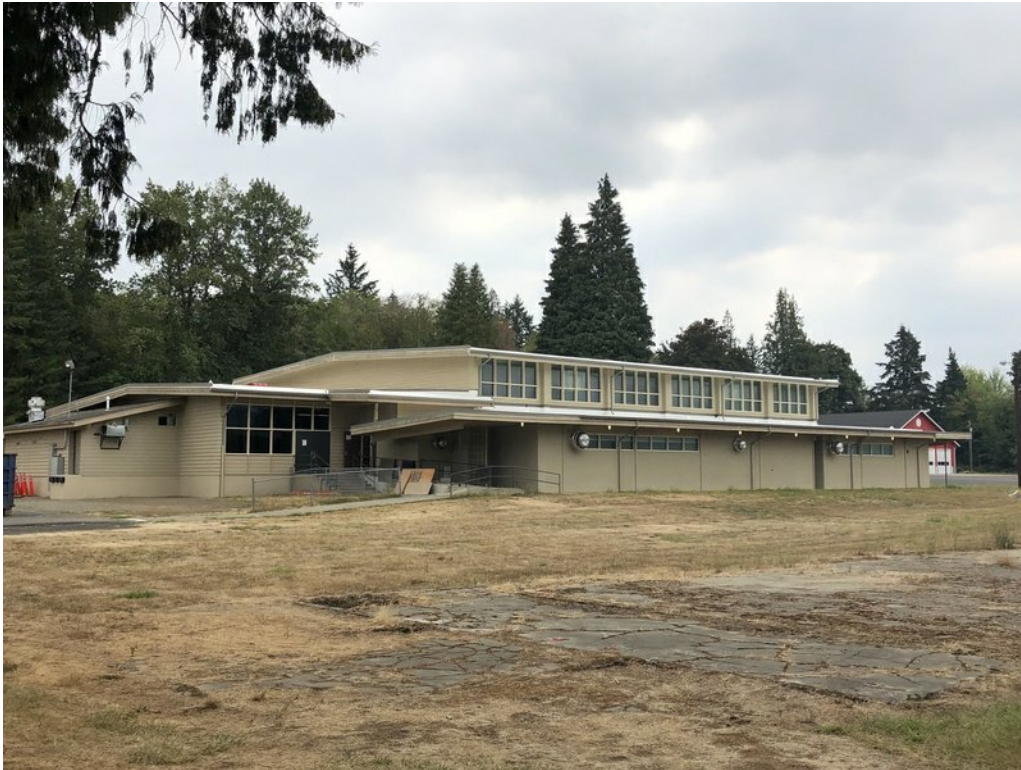
Deficiency	Description
Load Path	The windows along the east and west sides of the gymnasium create a break in the load path from the roof diaphragm to the masonry shear walls. In-plane strengthening is recommended, such as infilling windows with CMU or adding new shear walls or braced frames along the east and west sides.
Shear Stress Check	Shear stress for CMU walls is compliant. However, corresponding check for W2 system is non-compliant. The building likely requires lateral strengthening through the addition of new masonry shear walls. Further investigation is required.
Wall Anchorage	Roof exterior CMU wall connection types and extent are unknown. This evaluation item is likely non-compliant due to the building's age, but could not be visually verified. This item requires further field investigation to make a final determination on its compliance. The addition of out-of-plane wall anchors, blocking, and strapping is likely required.

**Figure 1-1. Boistfort Gym - West Exterior**

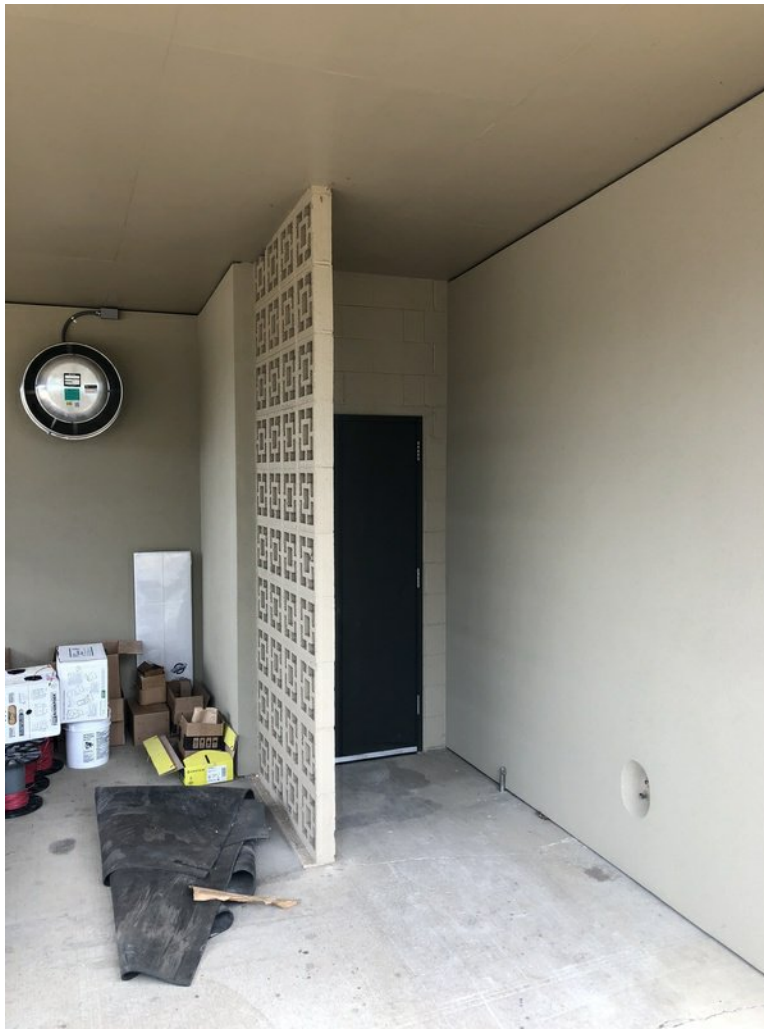
Deficiency	Description
P-1 Unreinforced Masonry. HR-LMH; LS-LMH; PR-LMH.	Partition wall at entrance to boys' locker room is likely unbraced based on the age of the building. This item requires further field investigation to make a final determination on its compliance and to develop a mitigation recommendation, if necessary. Unreinforced masonry partition walls should be braced at spacing of six feet or demolished.

**Figure 1-5. Unbraced Nonstructural Partition Wall at Entry**

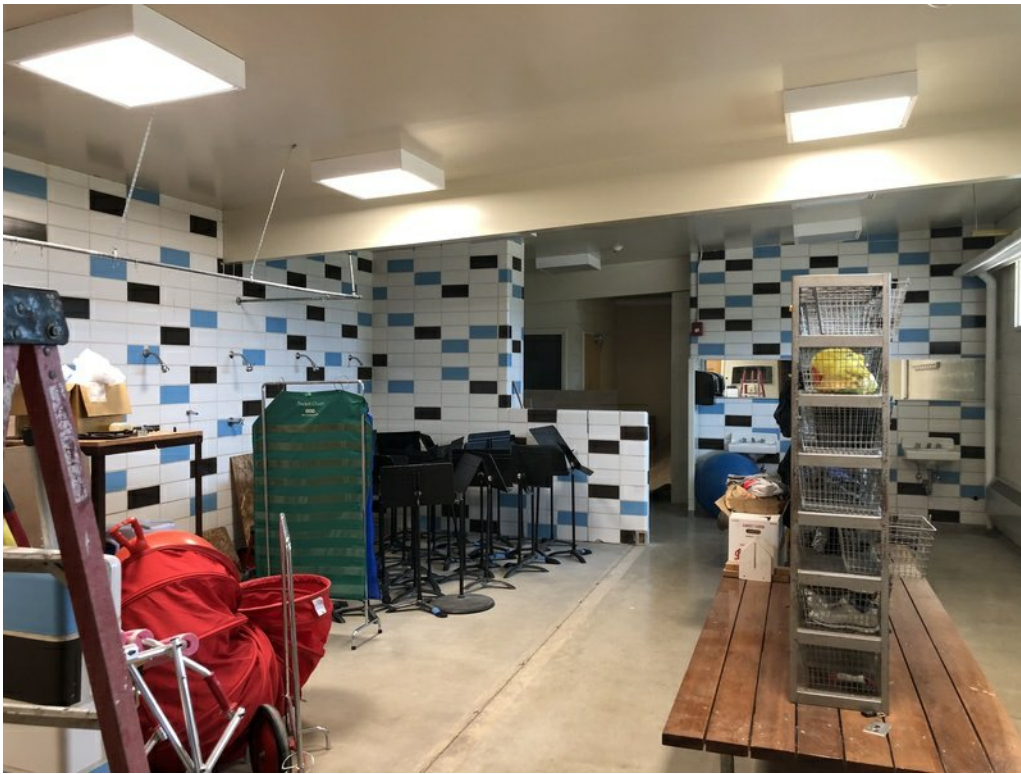
**Figure 1-6. Locker Room with Unbraced Half-Height Partition Walls**

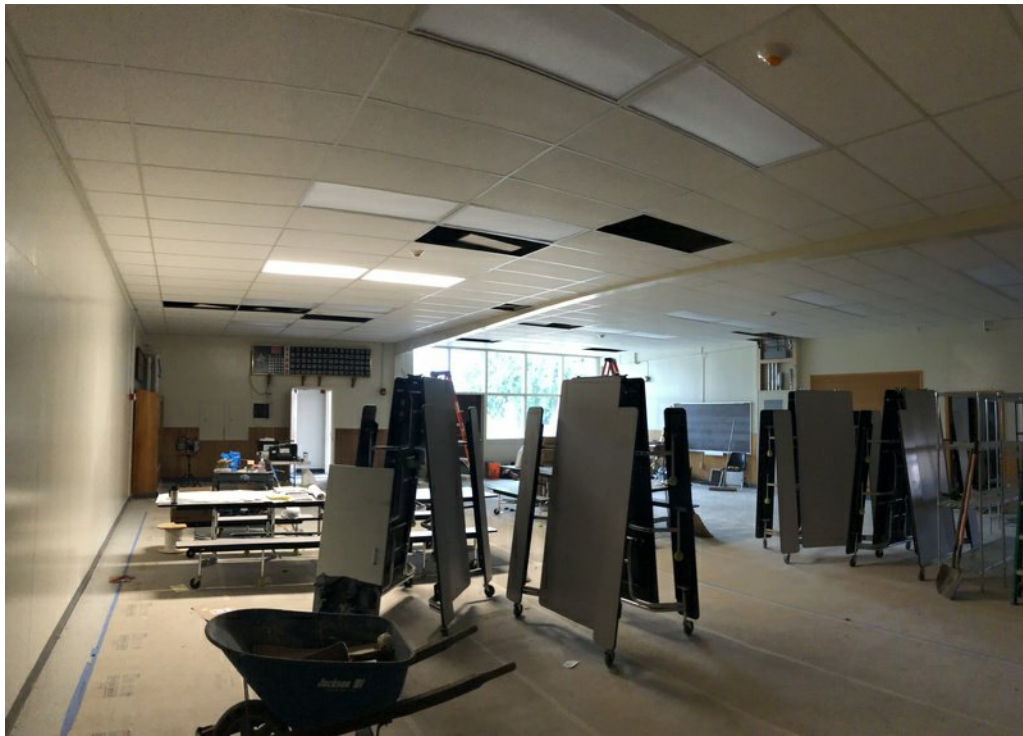
**Figure 1-9. Multipurpose Room with Unknown Light Fixture Bracing, Typical Throughout**

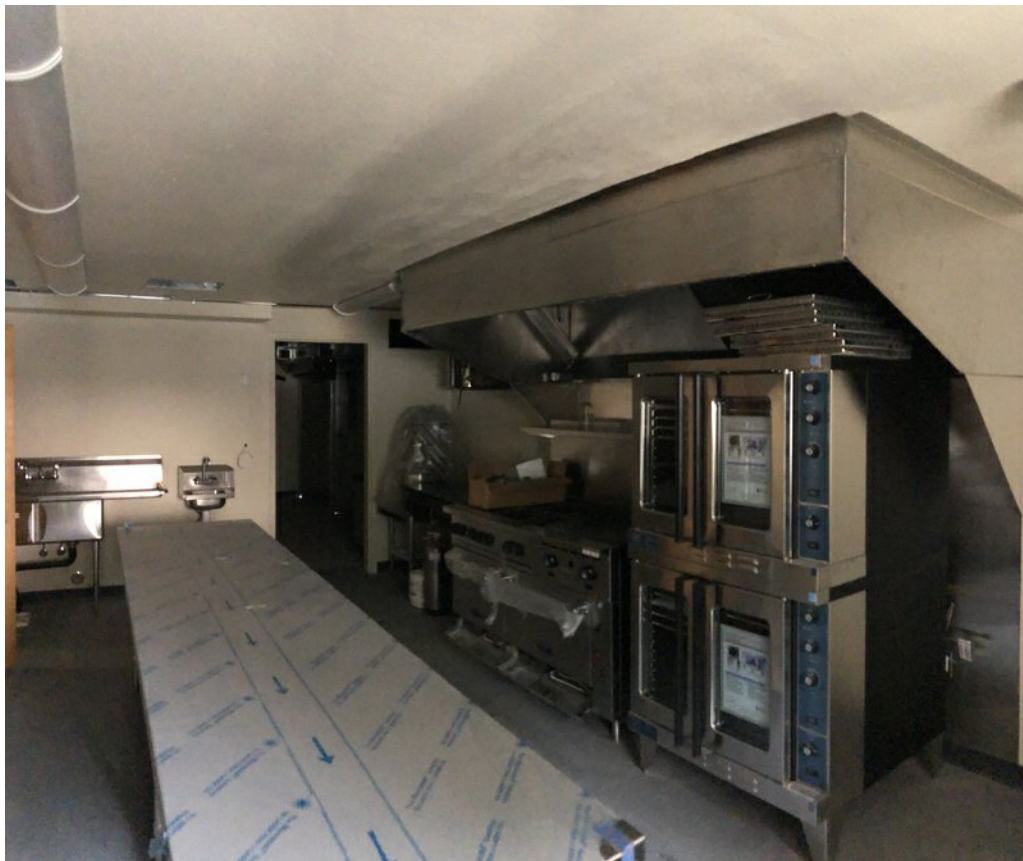
**Figure 1-10. Kitchen - Large Nonstructural Components Unbraced**

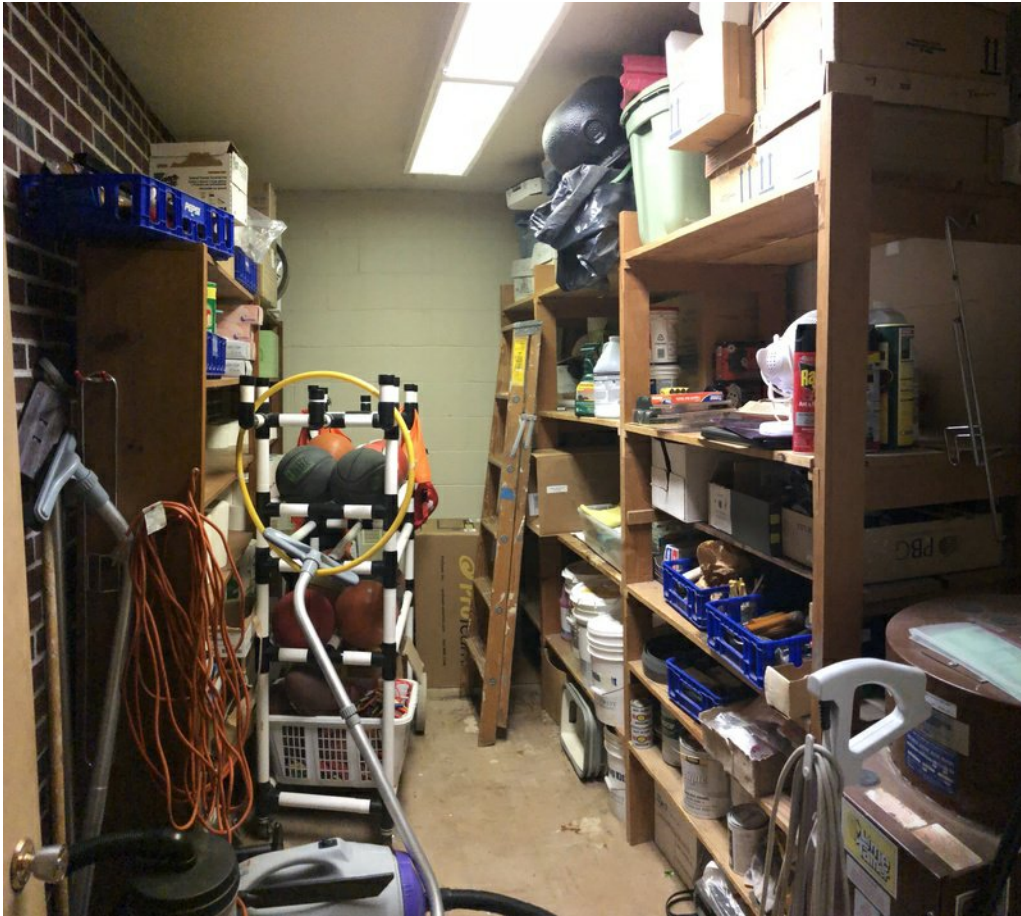
Figure 1-1. Storage Room at the CMU Addition. Original Unreinforced Masonry Wall Shown on Left.

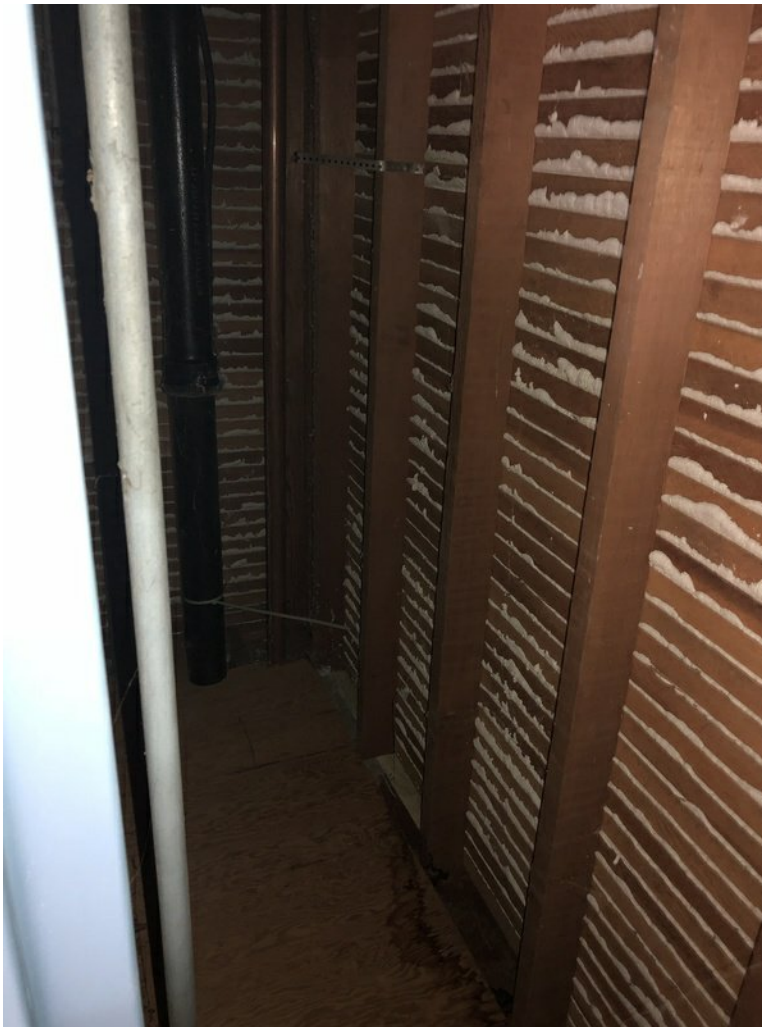
**Figure 1-3. Wall Space Showing Straight-Sheathed Walls**

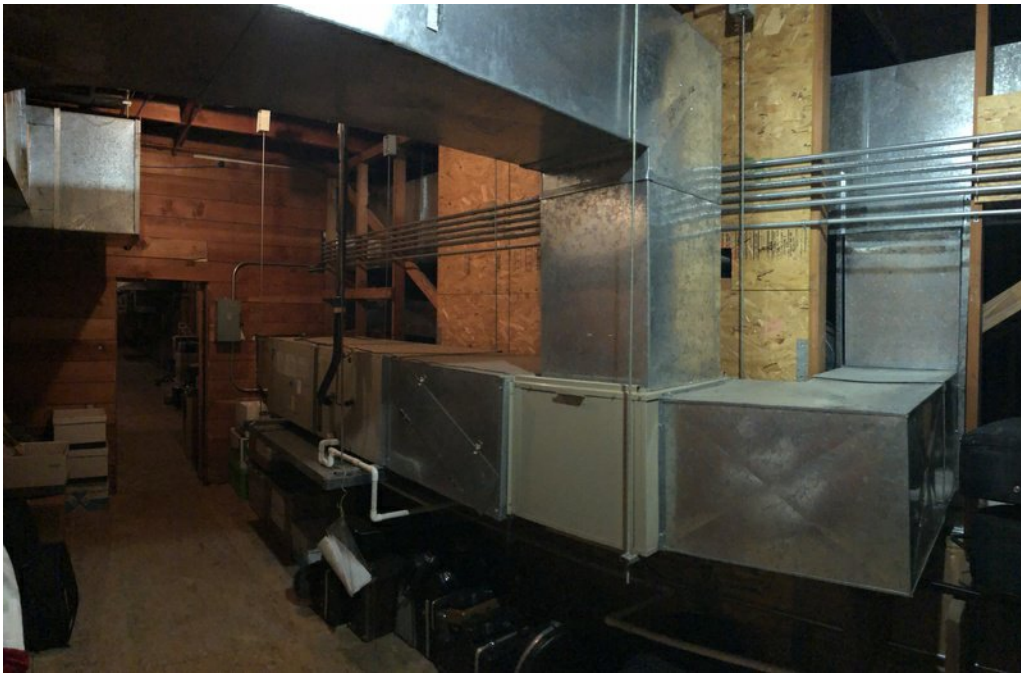
**Figure 1-4. Unbraced Ducts and Piping in Attic Space**

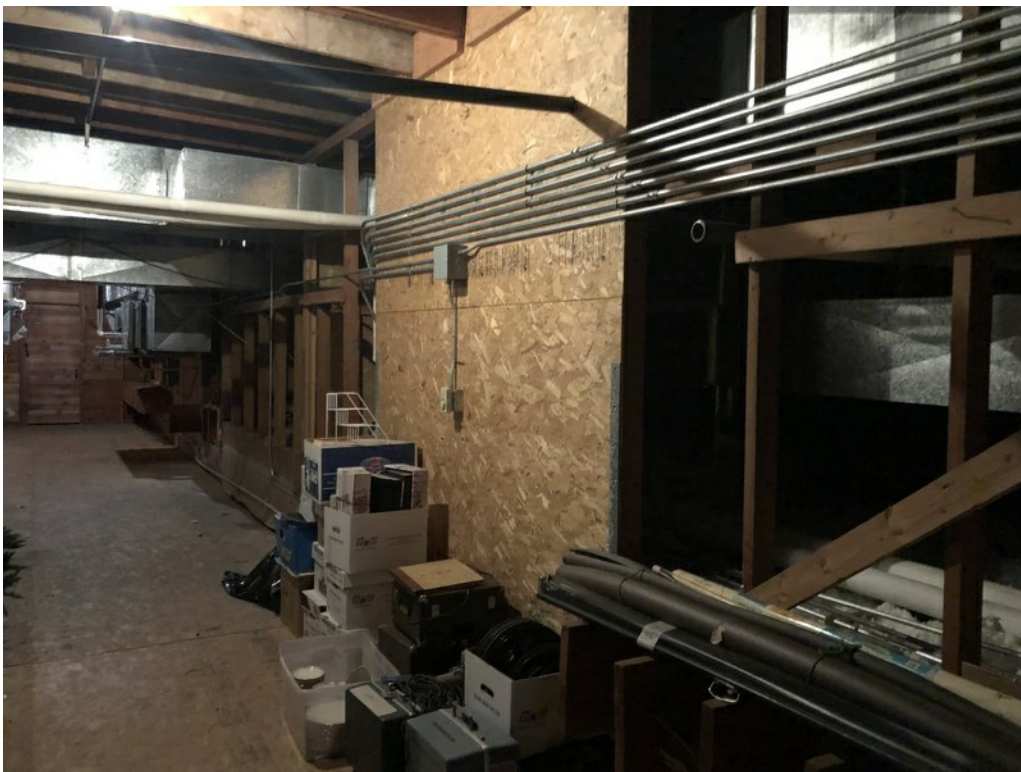
**Figure 1-5. New Plywood Shear Walls in Attic Discontinuous to Foundation**

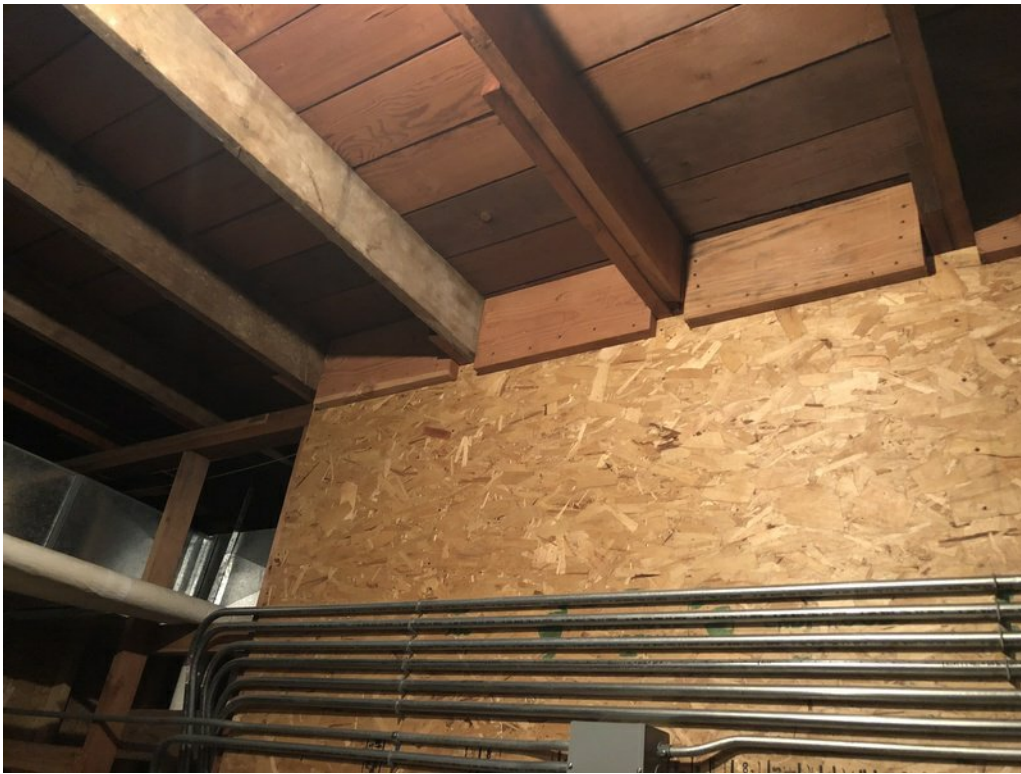
**Figure 1-6. Connection of Roof Diaphragm to Plywood Shear Wall Likely Inadequate**

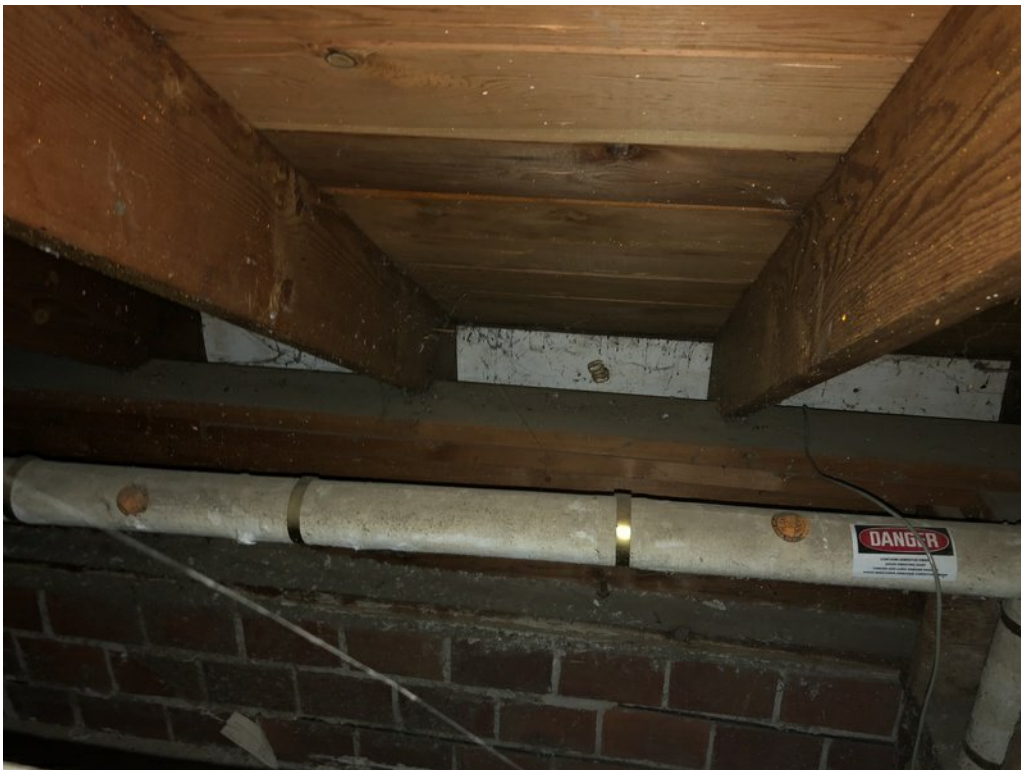
**Figure 1-7. Lack of Connection from Roof Diaphragm to Masonry Walls**

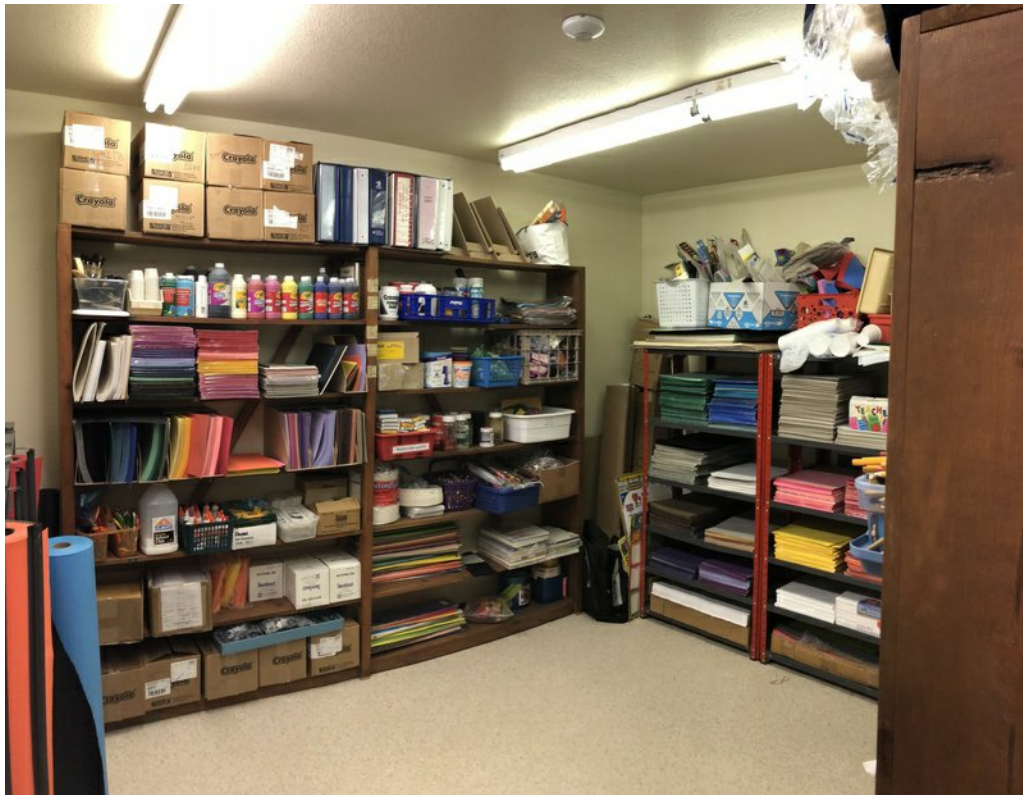
**Figure 1-10. Unbraced Tall Narrow Contents, Typical**
